## **Limited Visual Dam Safety Inspection Summary Report**

**MA-079**

**Reservoir 52**

**May 2006**

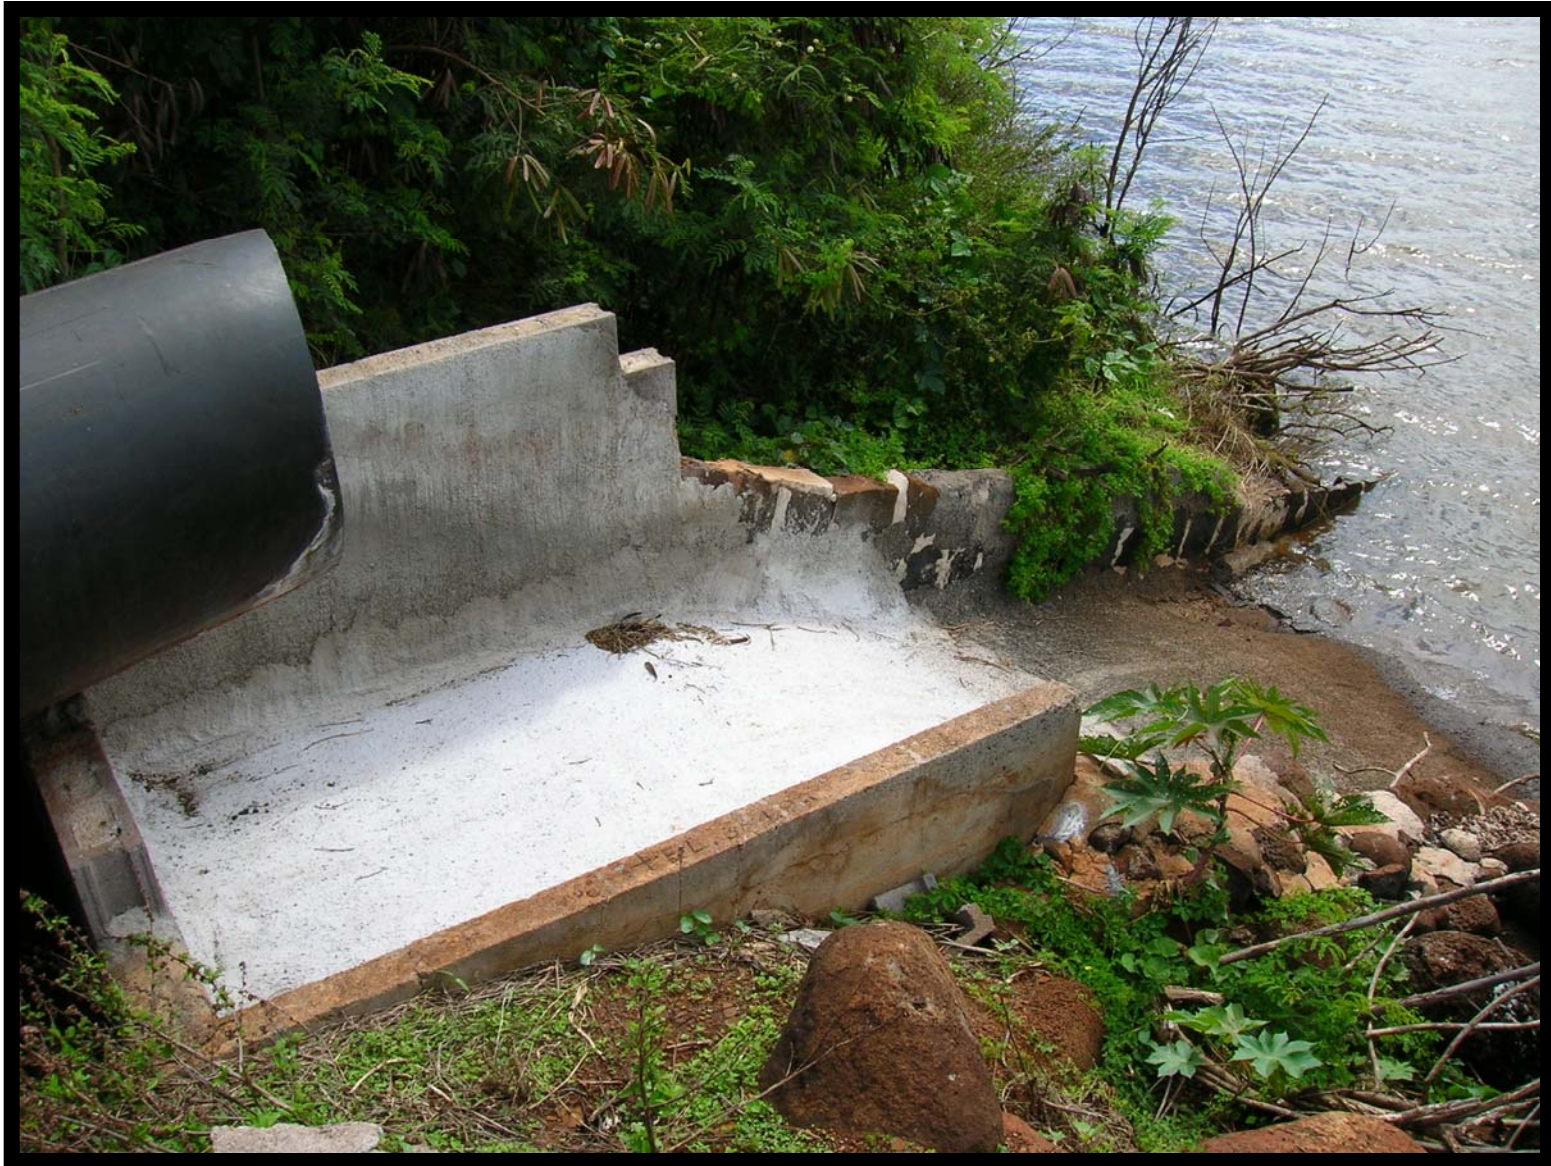
079 pump inlet

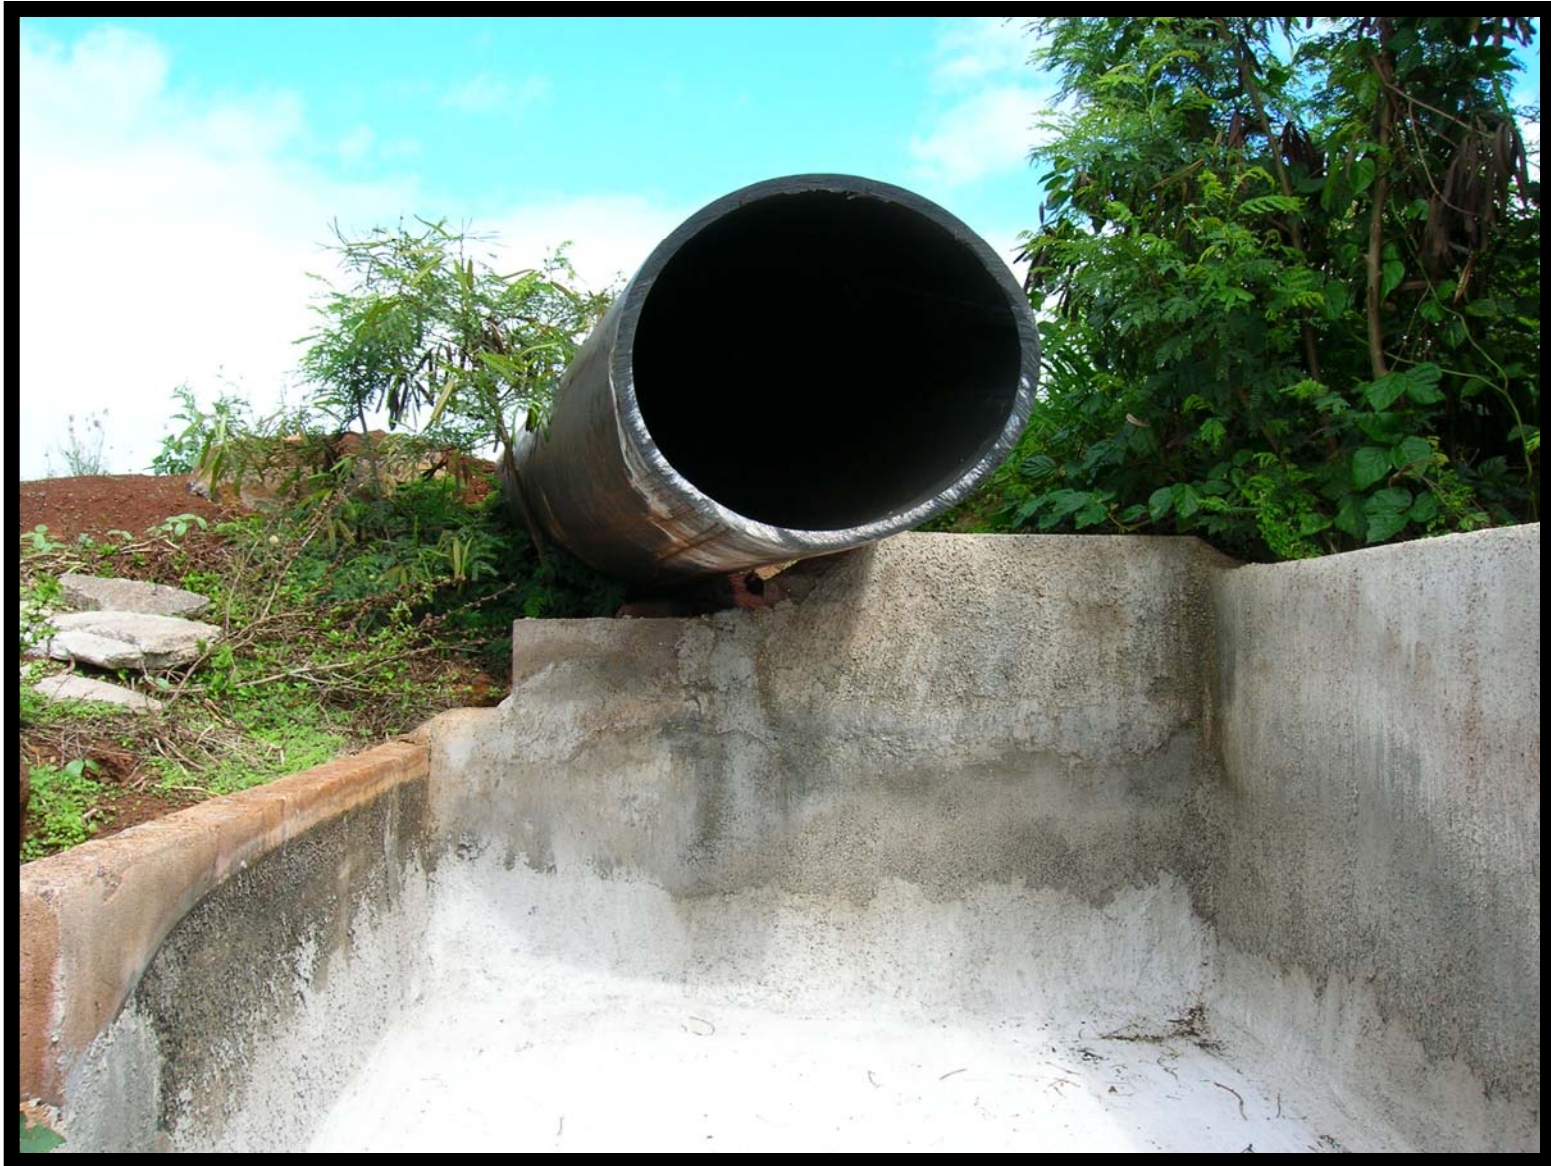
079 pump inlet 2

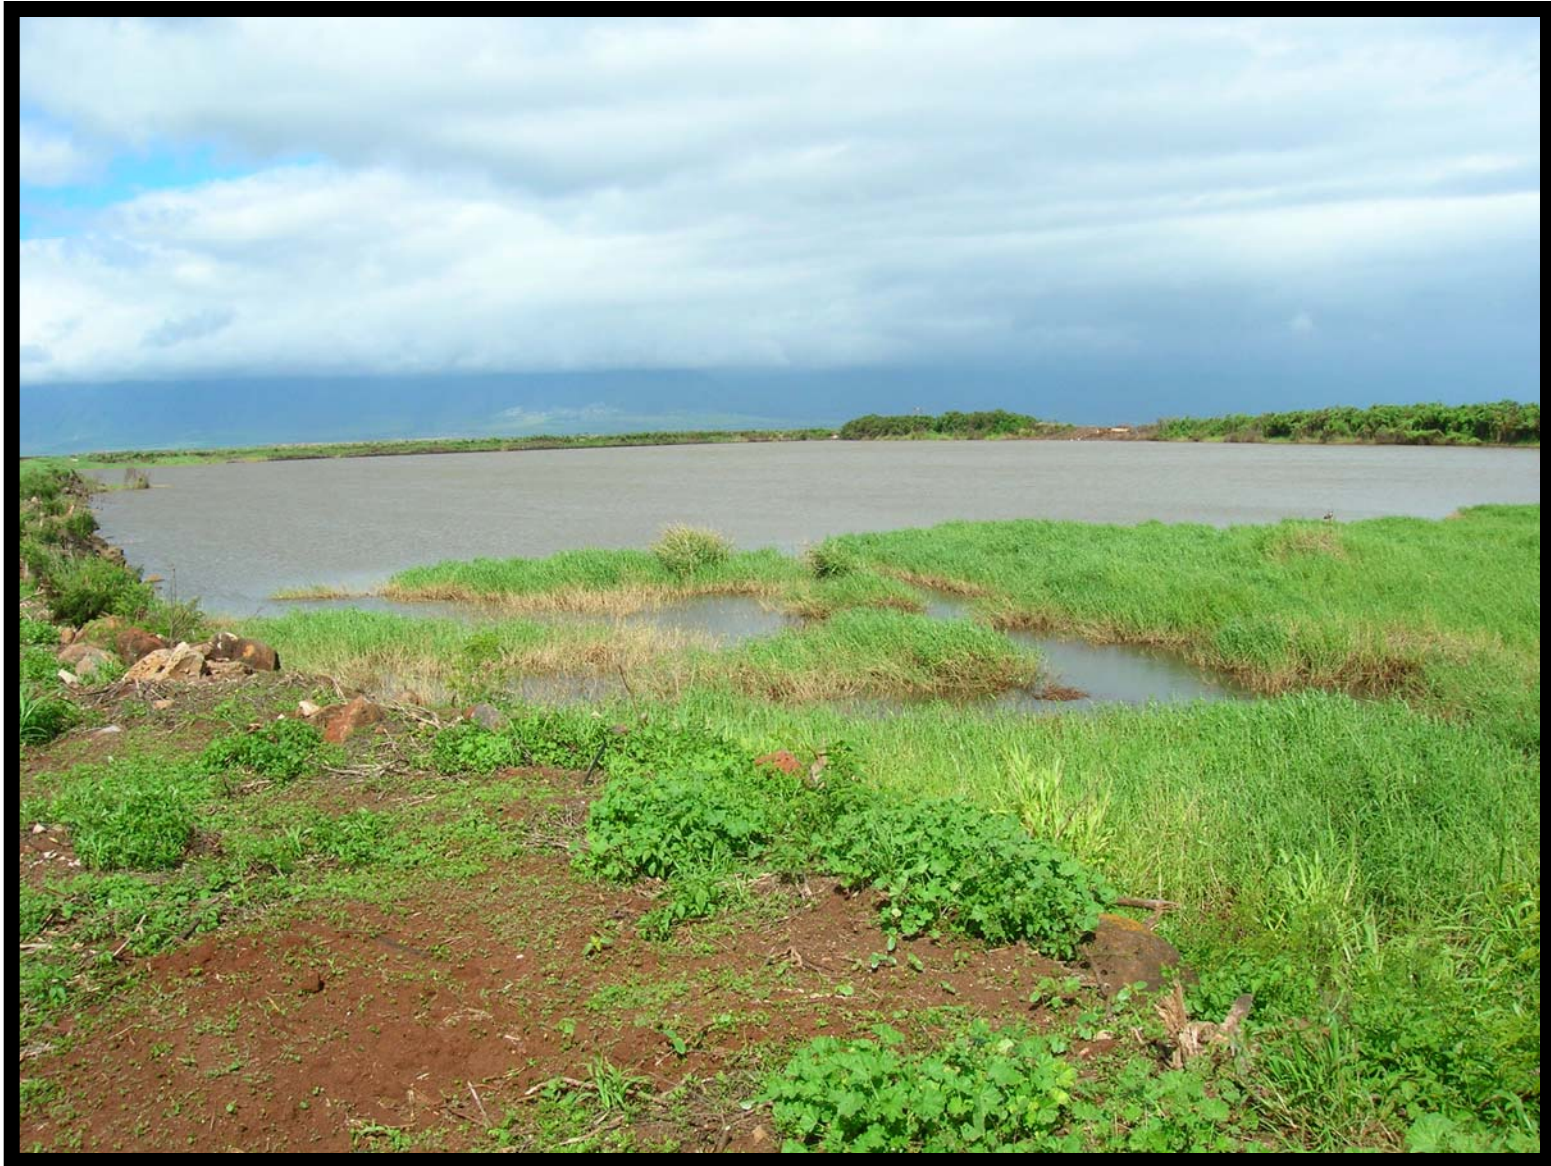
- a. The reservoir appeared to be in satisfactory condition, no corrective actions are required at this time.

079 reservoir

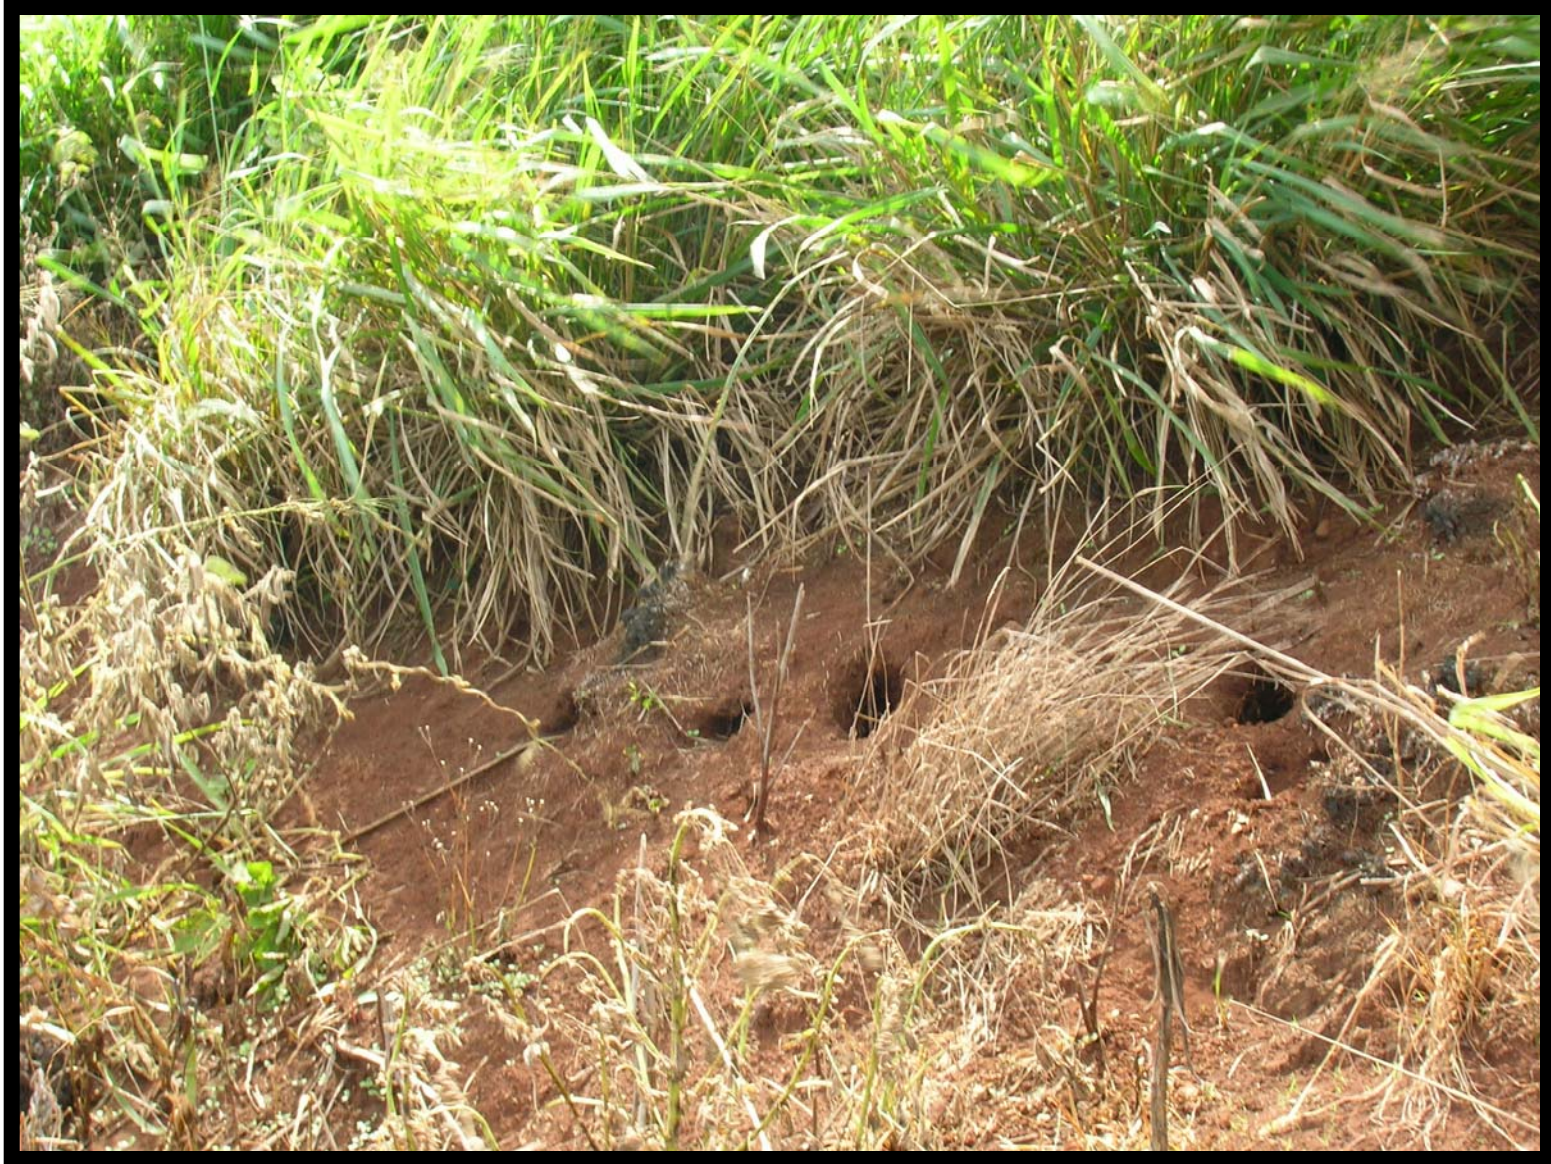
079 rodent holes

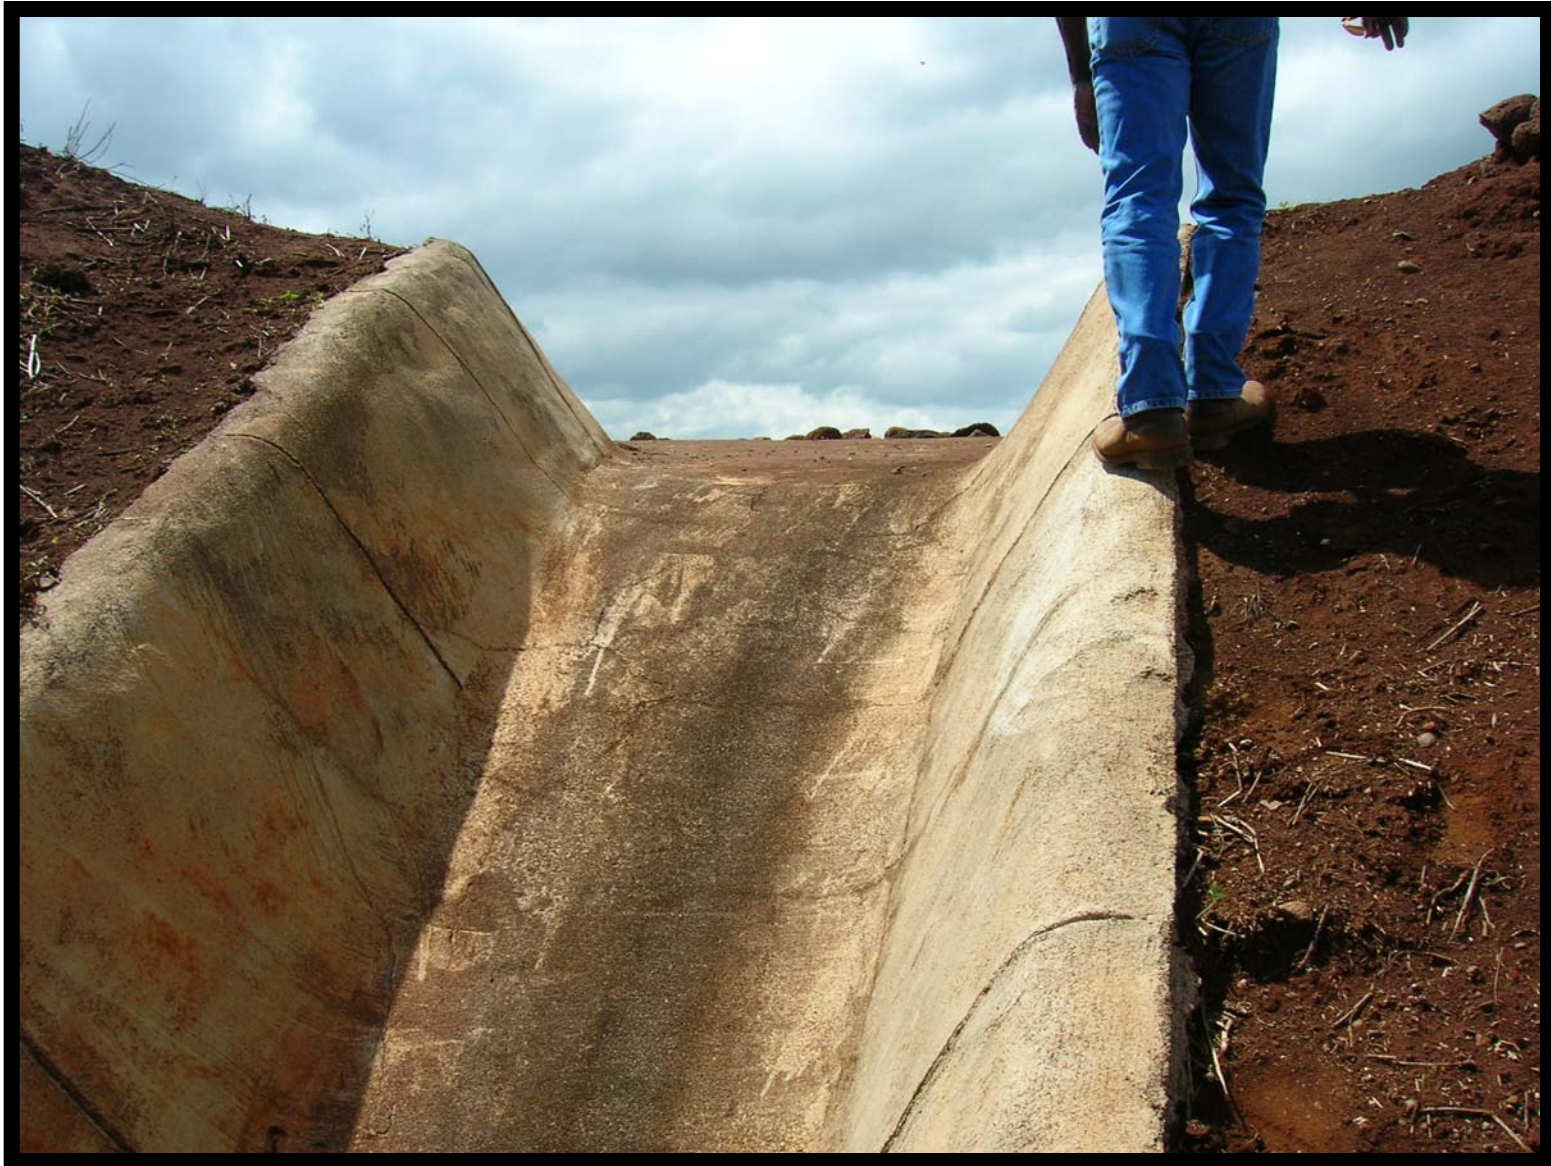
There was no erosion observed near the spillway.

- a. The Spillway appeared to be in fair to poor condition and requires corrective action.
- b. Unclear if spillway is adequately sized. Spillway should pass the probable maximum flood. Verify spillway capacity and take corrective action as required.

079 spillway

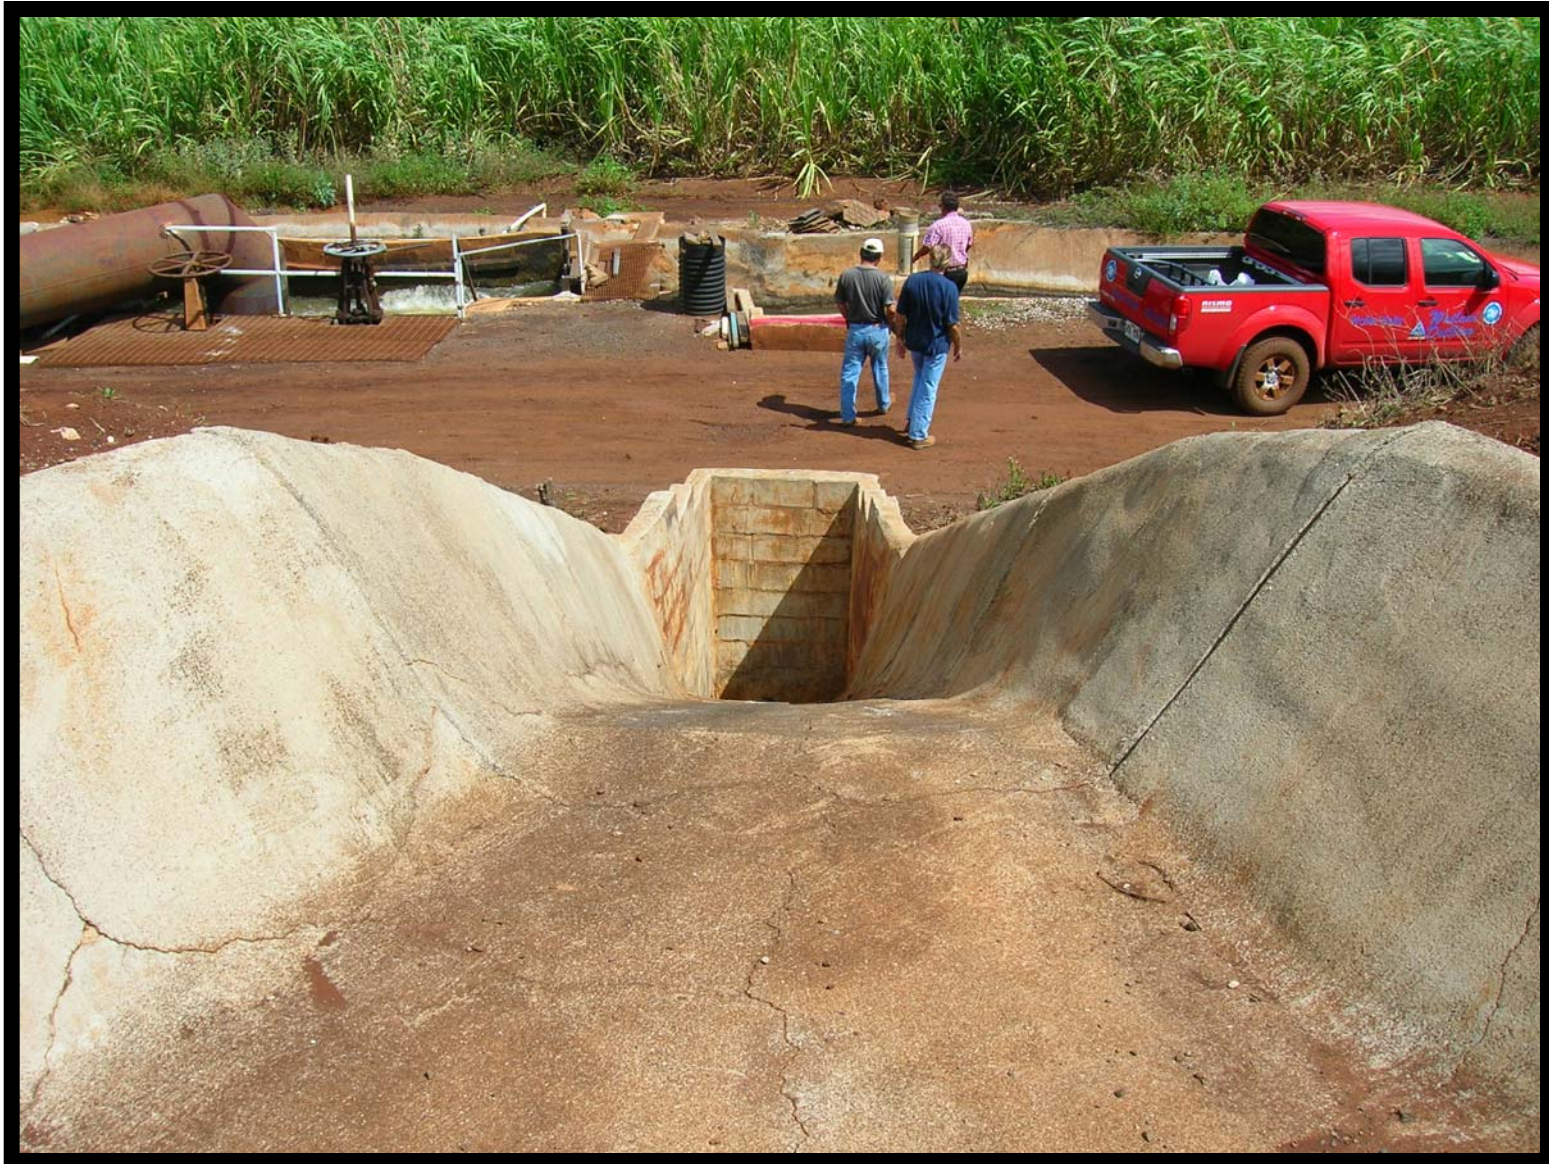
079 spillway 2

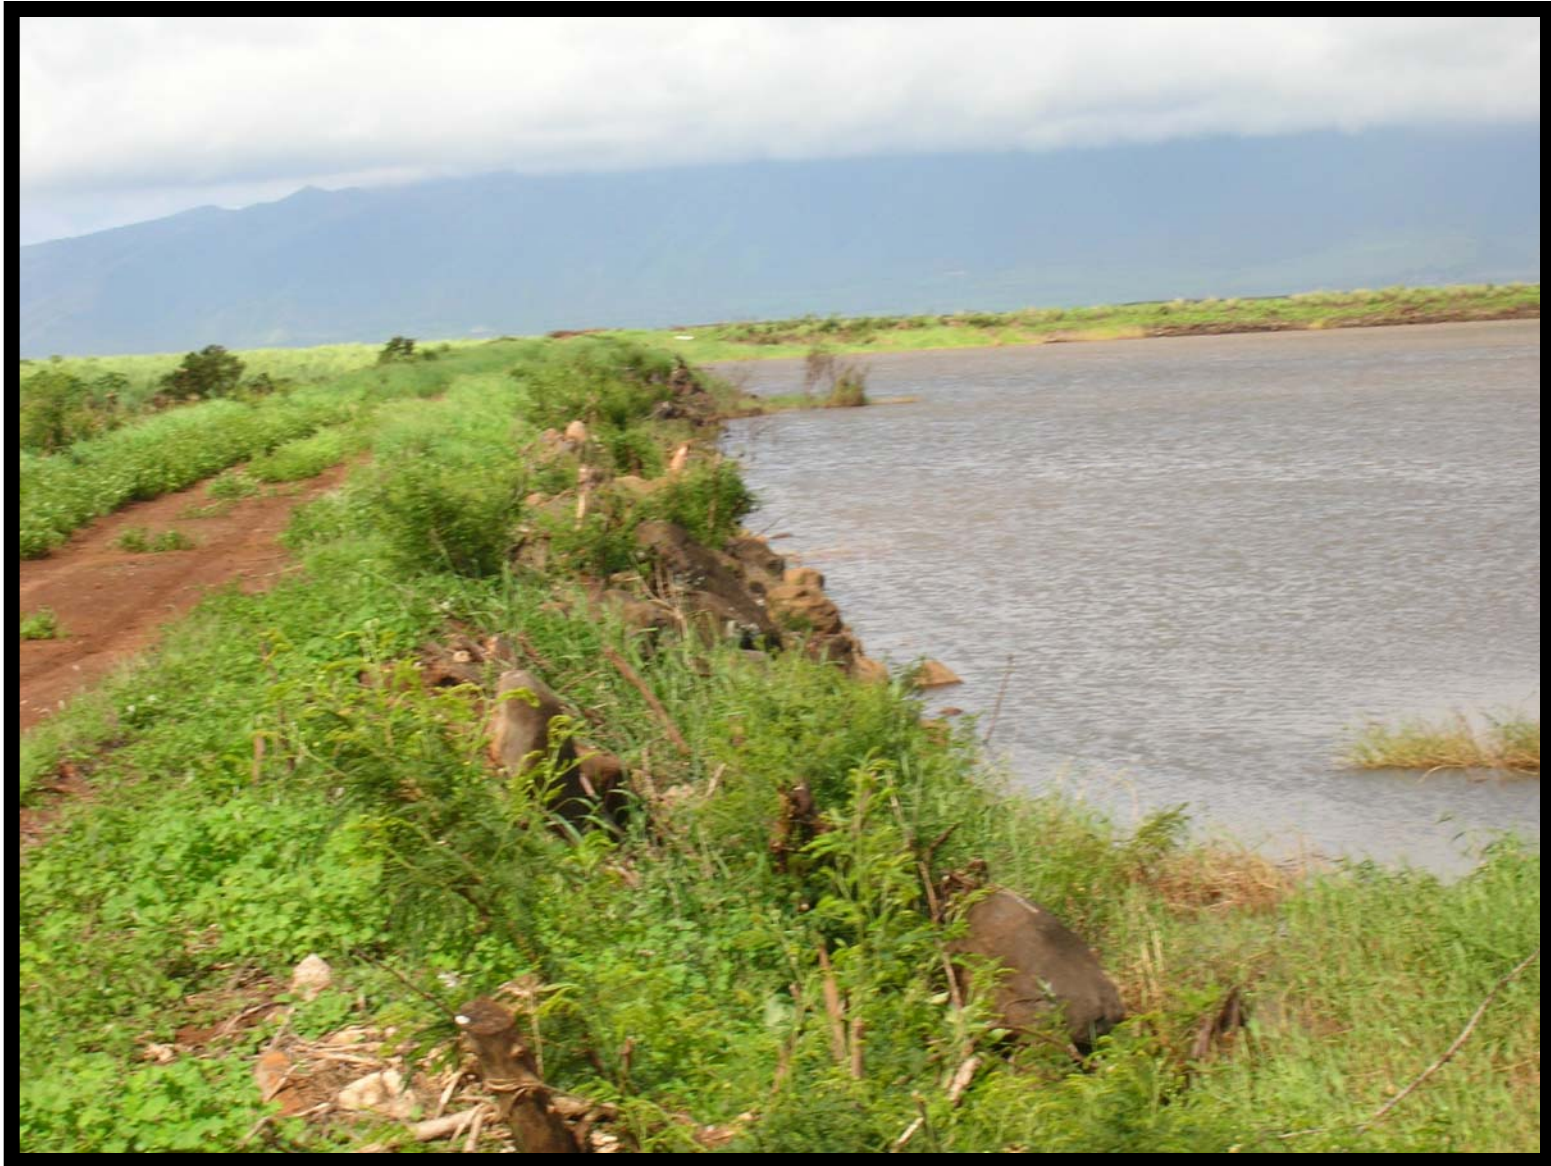
A fitted rip rap rock slope protection was observed. Vegetation was observed growing between the rocks.

Cracks were not visible; the slope was not entirely visible.

- a. The upstream slope appeared to be in fair to poor condition and requires corrective action.
- b. The upstream slope was not visible due to high grass and bush vegetation. Clear high vegetation and maintain low to enable easy visual inspection.
- c. Tree(s) were observed on the dam embankment. Trees have been identified as the probably cause of piping failures, and can possibly cause sever damage to the embankment if they are uprooted during a high winds. Corrective action is required to remove the tree hazards from the dam. Acceptable remedies include removal of the tree and its root structure down to a 2" diameter and reconstructing the damaged embankment section. All repair work shall be accomplished as per the requirements of licensed geotechnical or structural engineer. Routinely monitor the damaged area for signs of settlement and seepage.

079 upstream slope

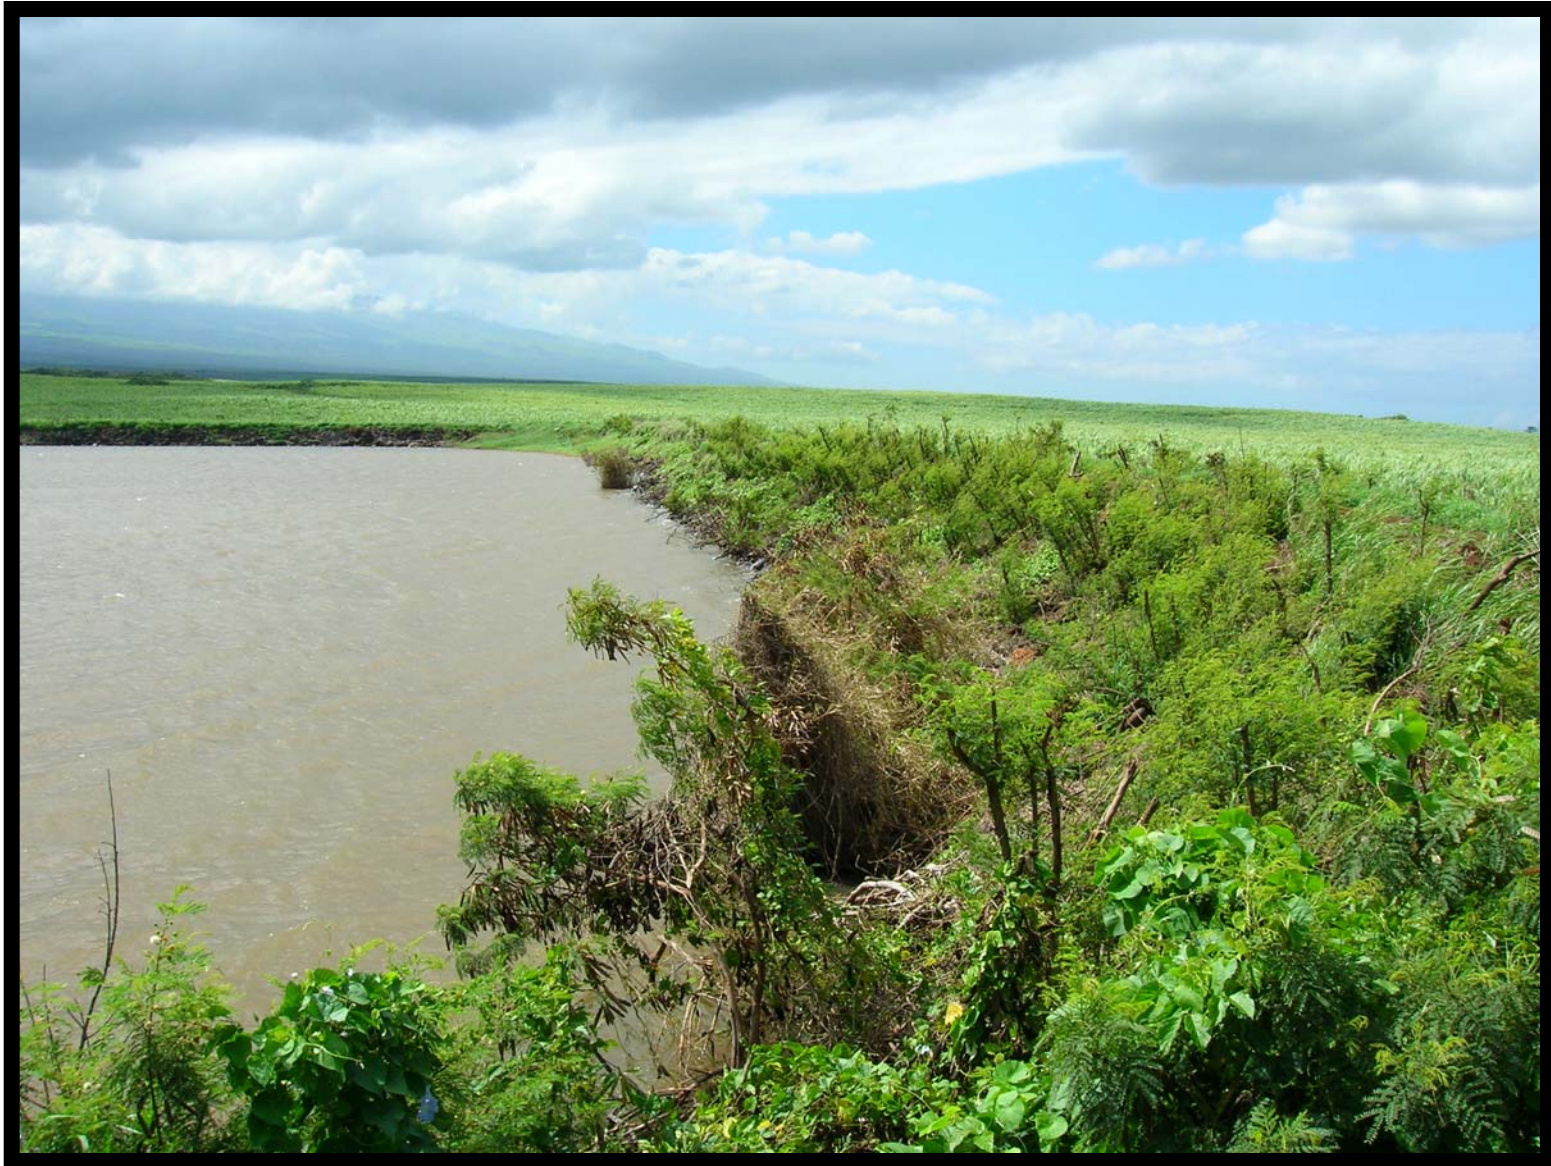
079 upstream slope 2
